Stormwater Asset Management Program

Town of Alton, NH

April 2024

Tighe&Bond

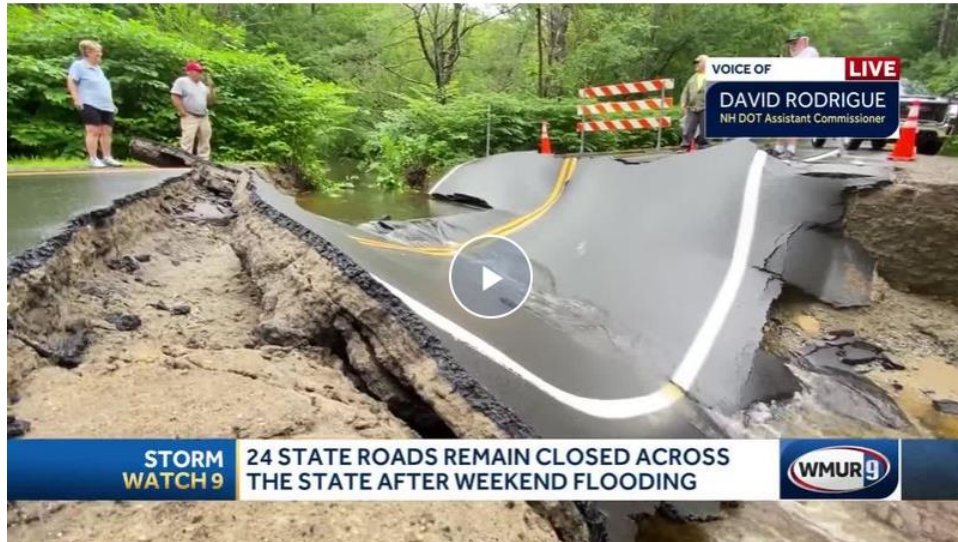
Figure 1-1 Result of a Failed Culvert in Alton¹

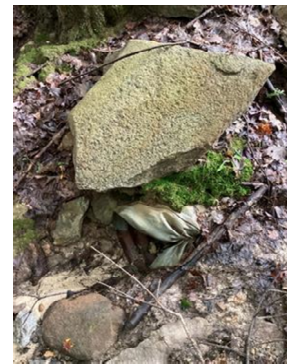
Outlet:

**Planning Level Engineer's Opinion of Probable Construction Cost
CLVTPipe-248 (18" RCP, 39' Long) Culvert Replacement
Muchado Hill Road
Town of Alton, NH**

Reason: This culvert had a PoF score of 2.03 and a CoF score of 1.87 and an overall risk score of 0.42. This culvert had significant invert deterioration and section loss.

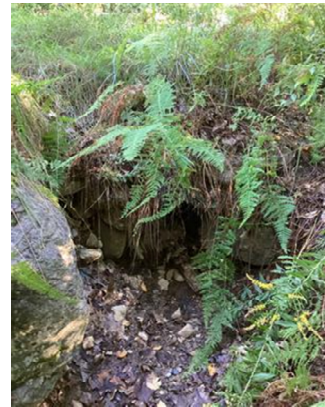
Outlet:

**Planning Level Engineer's Opinion of Probable Construction Cost
CLVTPipe-294 (15" RCP, 41' Long) Culvert Replacement
Old Wolfeboro Road
Town of Alton, NH**

Reason: This culvert had a PoF score of 1.65 and a CoF score of 1.62 and an overall risk score of 0.30. This culvert had some fill infiltration and a failed pipe segment.

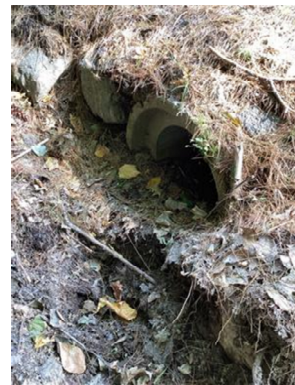
Outlet:

**Planning Level Engineer's Opinion of Probable Construction Cost
CLVTPipe-321 & 322 (9.75' Box, 61' Long) Culvert Replacement
Swan Lake Trail
Town of Alton, NH**

Reason: Culvert CLVTPipe-321 had a PoF score of 1.39, a CoF score of 1.63, and an overall risk score of 0.25. Culvert CLVTPipe-322 had a PoF score of 1.39, a CoF score of 1.47, and an overall risk score of 0.23. Both of these culverts had significant invert deterioration and both headwalls were subject to deterioration.
