Stormwater Asset Management Program

Town of Alton, NH

April 2024

Tighe&Bond

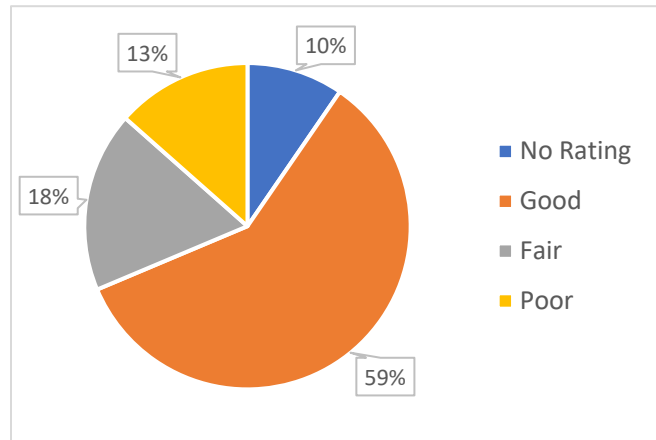
Figure 3-1 Distribution of Culvert Inlets by Condition

Tables 3-1 through 3-3 and Figures 3-1 through 3-3 demonstrate the distribution of the culvert inlets, pipes, and outlets by condition. During the field inspections, no culverts were identified as being in active failure mode; however, a number of culverts were identified to be in poor condition as shown below and should be addressed over the next five years.

Condition	Number Inspected	% Total Number of Culvert Inlets
No Rating ⁹	37	10%
Good	228	59%
Fair	69	18%
Poor	52	13%

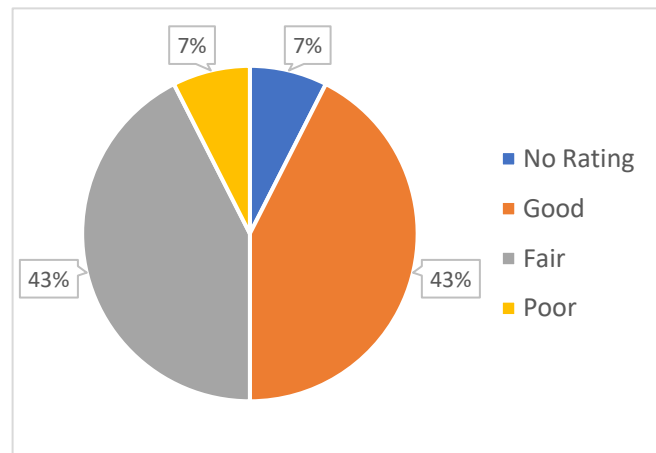
Figure 3-2 Distribution of Culvert Pipe by Condition

Condition	Number Inspected	% Total Number of Culvert Pipes
No Rating ⁹	47	7%
Good	267	43%
Fair	267	43%
Poor	47	7%

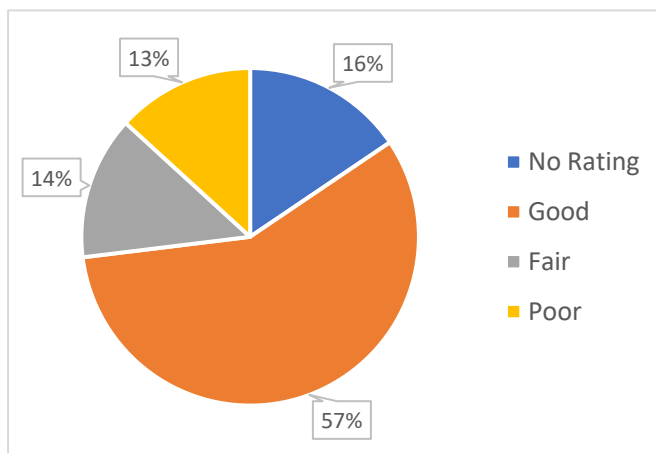
Figure 3-3 Distribution of Culvert Outlets by Condition

Condition	Number Inspected	% Total Number of Culvert Outlets
No Rating ⁹	60	16%
Good	222	57%
Fair	53	14%
Poor	51	13%

⁹ The majority of culverts listed with a condition of 'No Rating' represent culverts that could not be located or accessed for condition assessment or had no end treatment type.

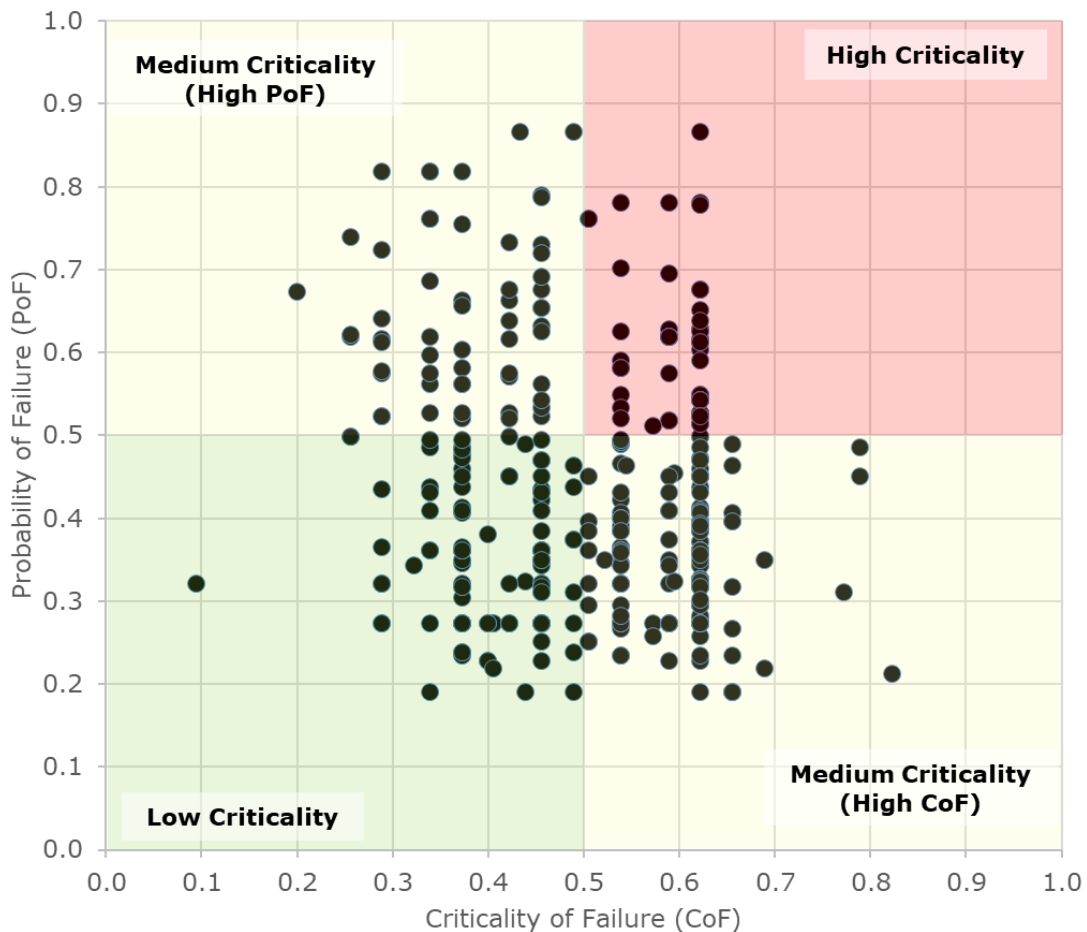
Figure 5-2 Culvert Risk Matrix

A criticality matrix was created within Excel and the result is shown in Figure 5-2 below. Each culvert is shown per its risk category assigned based on the Probability and Consequence of Failure. Note that each dot in the figure below may represent multiple assets with the same score. As the asset prioritization is updated in the future, this asset risk matrix should be updated to include new data added by expanding the chart’s source data selection in Excel.

The Overall Criticality Scores and Rankings in **Appendix J** provide the overall criticality score for each culvert by summing the PoF and CoF scores for inlet, pipe, and outlet components and multiplying these overall PoF and CoF scores. **Appendix J** also identifies the assigned high, medium, and low criticality category for each culvert based on the methodology described in Table 5-1 above. 52 culverts were determined to be in high criticality category, 225 were determined to be in medium criticality category, and 109 determined to be in low criticality category. As discussed in Section 6.1 below, 12 culverts are recommended for replacement or repair.
